# Sustaining Farming on the Urban Fringe

March 2007

## Sharing our Greenhouse Re-glazing Experience

### *A 2<sup>nd</sup> Energy Conservation Life for Old Glass Greenhouses*

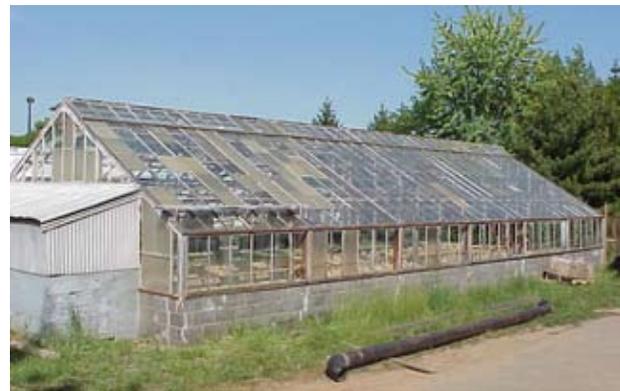
*Before: greenhouse in need of repair, May 2005*

At Rutgers NJAES on campus, an old greenhouse used by our turf breeders sorely needed re-glazing. It was debated whether to reset original glass, re-glaze with a double wall plastic panel, or even demolish it. We needed space and could not afford new construction. There were many factors to be weighed; costs of the project, energy conservation, maintenance issues with glass vs. plastic, and overall life expectancy. We also wanted to perform all work with our own fabrication shop and greenhouse crew to reduce expenses. After figuring out how much time it would take to clean, caulk and reset glass, we decided to re-glaze with 8 mm polycarbonate.

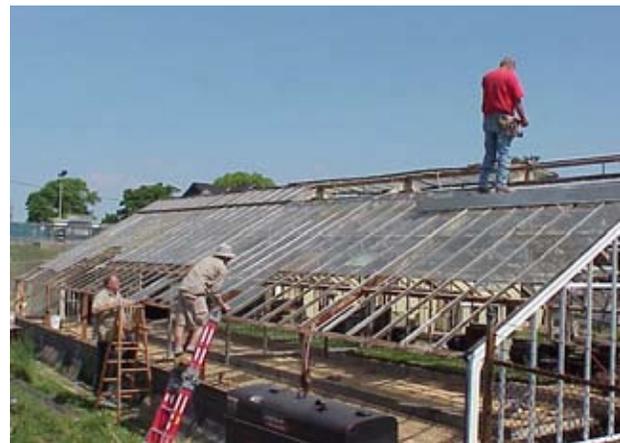
*Removal of glass*

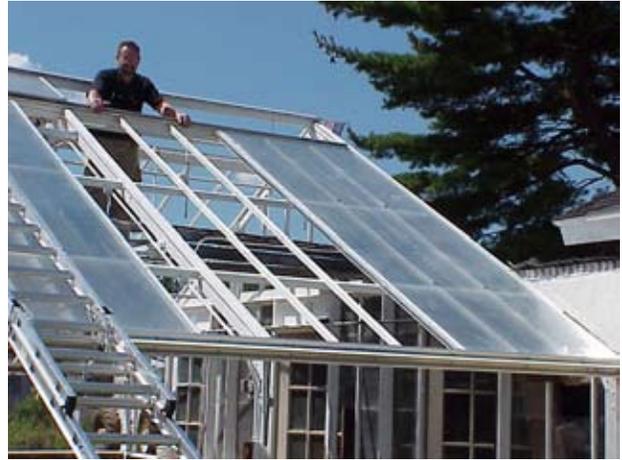
*Re-glazing in progress*

We were assisted with our project by Bill Rowohlt of Ludy Greenhouse Manufacturing. Bill figured out the material list and provided tips on panel installation. The learning curve was quick and work progressed well. One thing we found in the process was the greenhouse was no longer square; roof dimensions varied by as much as an inch. By using a scrap piece of plastic panel, cut to length, we adjusted upper glazing supports up or down as needed before installing a full size panel.

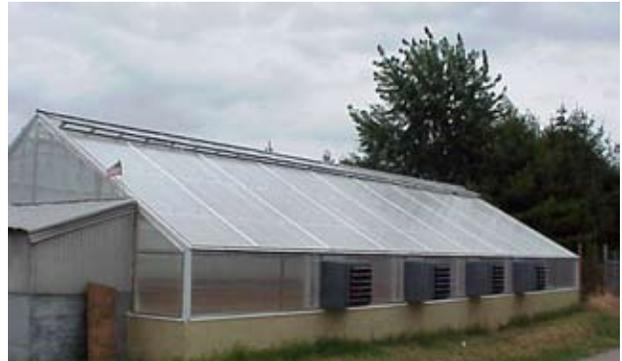
*After: re-glazed greenhouse, September 2005*

Our results at NJAES are a leak-proof, draft-free greenhouse and a substantial savings in energy use (approximately 30%). The cost of materials to re-glaze this 25'x50' greenhouse in 2005 was \$8,500 which included re-glazing the sidewalls and roof vents. As you can see from the pictures, the looks of the greenhouse improved dramatically as well.
